Summary of **Nordic Enterprises'**

**Report of Tests and Observations made at the
Canadian Forces Base Edenvale on the Facultative
Sewage Lagoon Using BIOLOGIC**

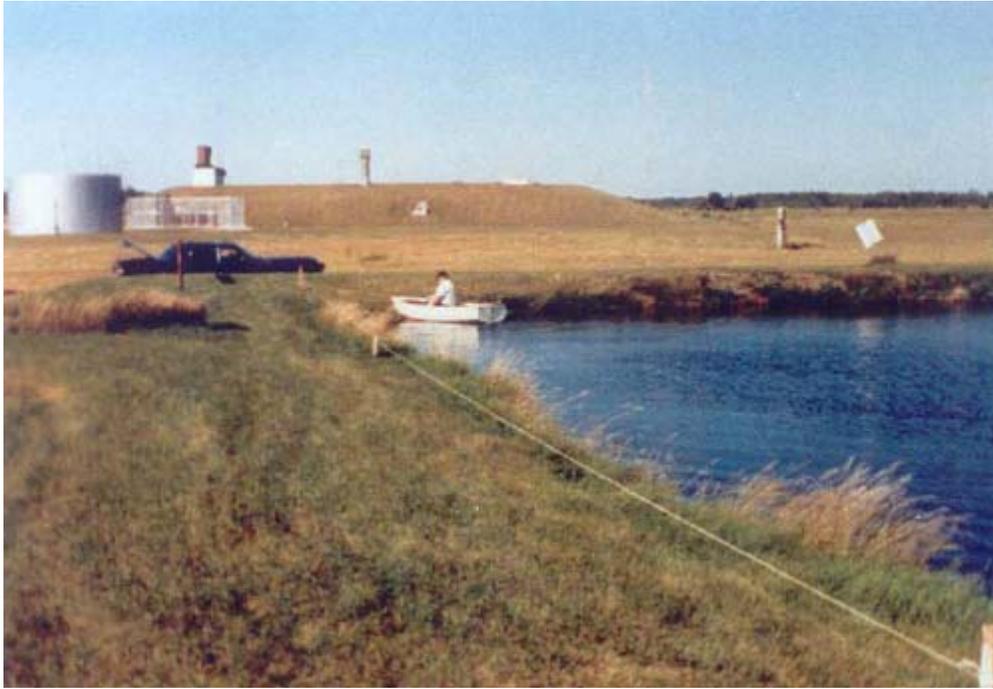
1. Ropes for grid pattern, looking S.E.

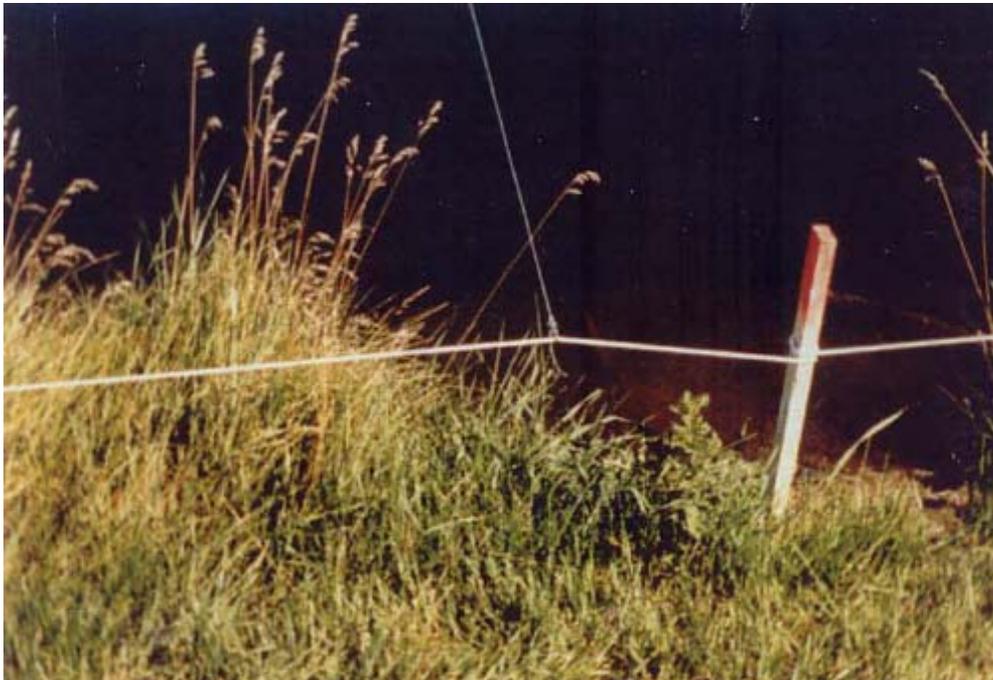
2. Shows clarity of water from pole outward. Visibility is only 6" deep. Bottom is a light sand colour. Also shows grid for sludge measurements.

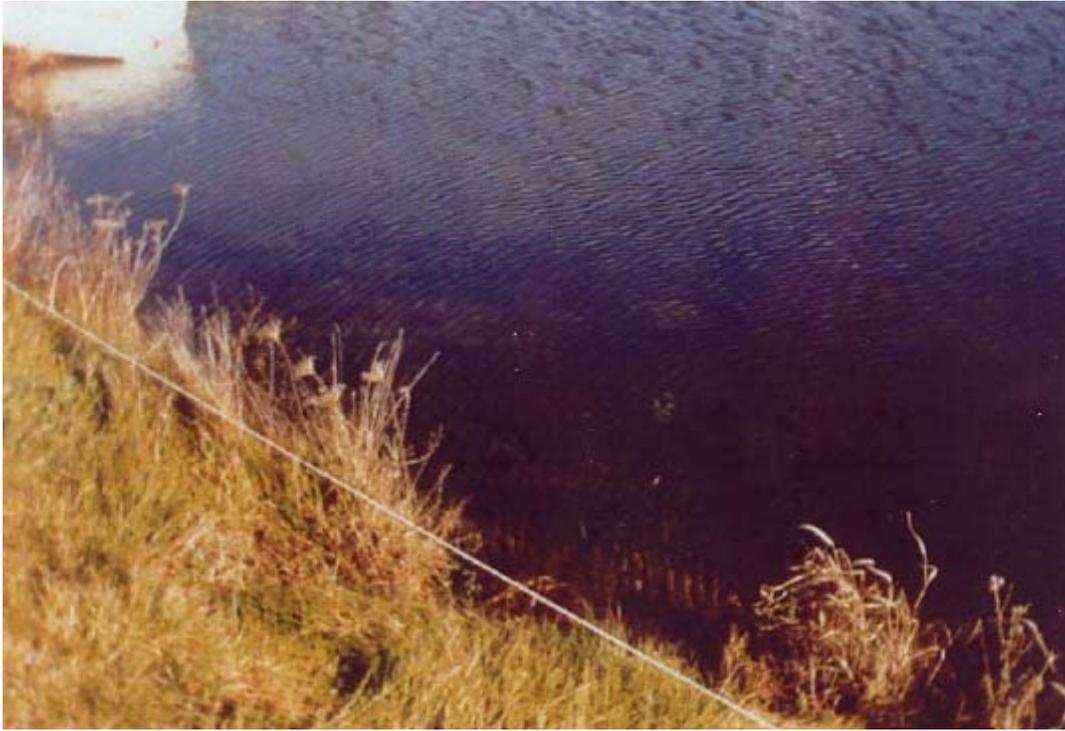
2. Bottom of the lagoon after BIOLOGIC. Compare clarity to Photo #2.

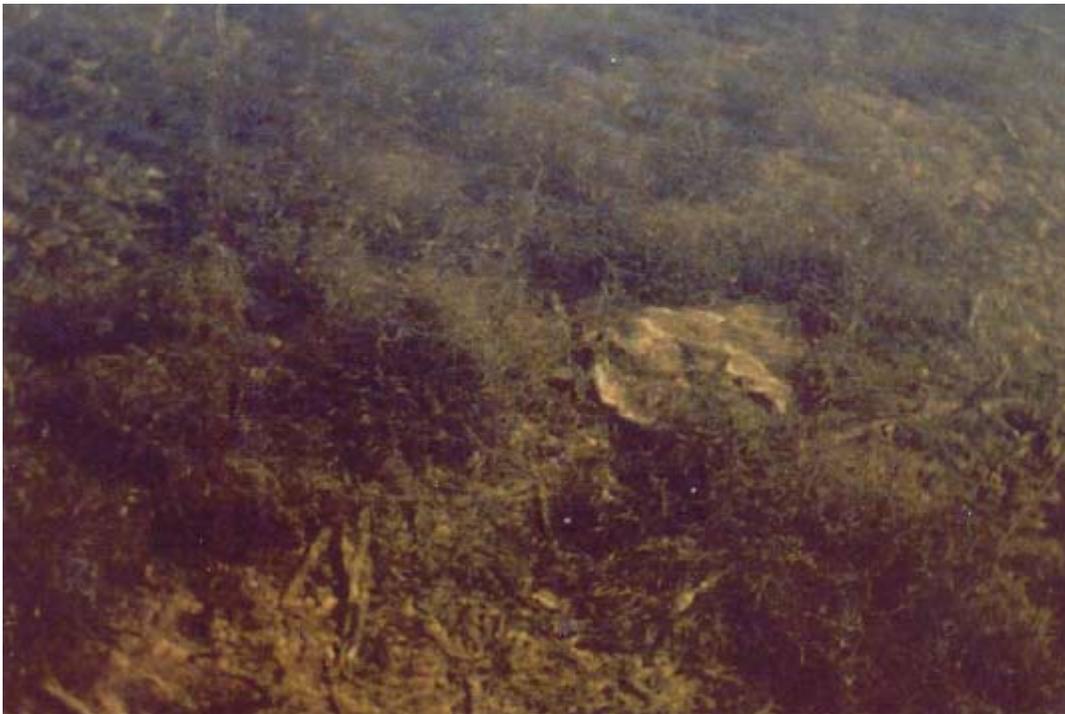
4. Bottom of the lagoon in S.E. corner as seen from boat. Can see 5 ½ feet deep

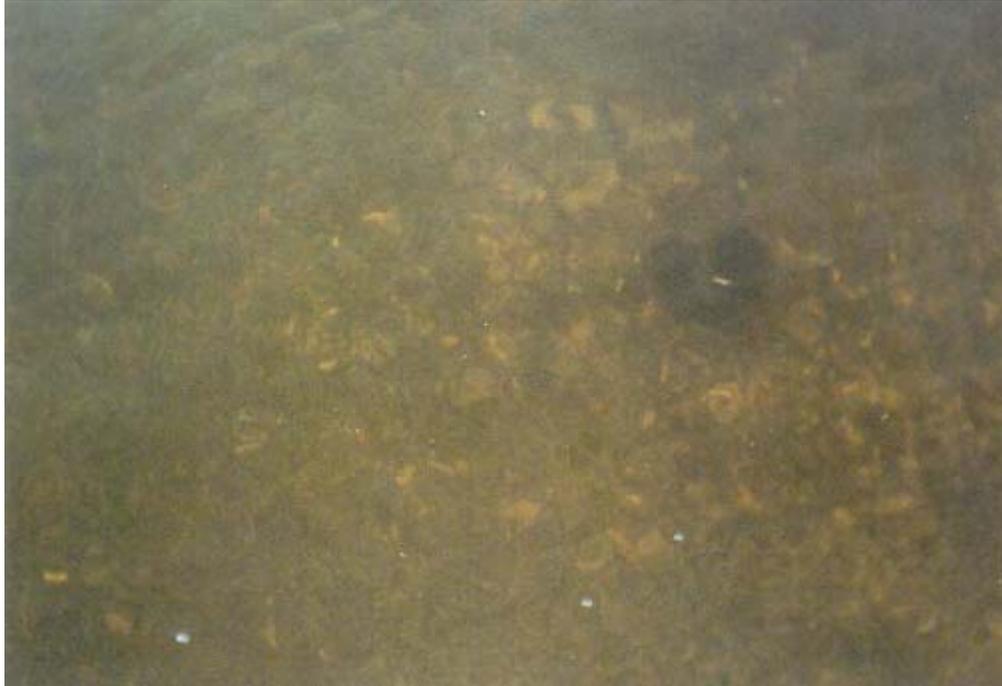
5. Looking directly down from boat (visibility 5 ½ feet). Note inlet pipes.

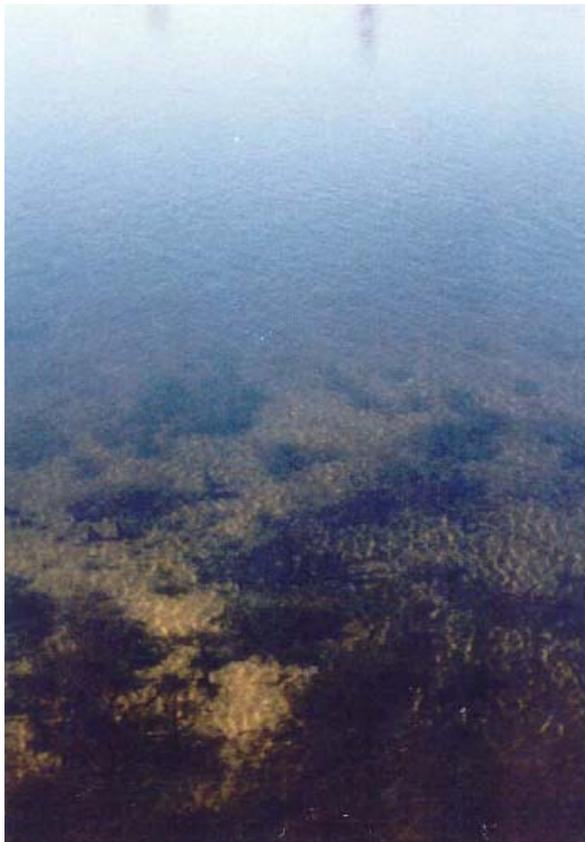
6. Algae and under growth, with no sludge remaining on algae (N. side).
